# The BULLETIN

## CARTELA RESTORATION PROJECT

### UPDATE #7

Friday, January 03, 2014

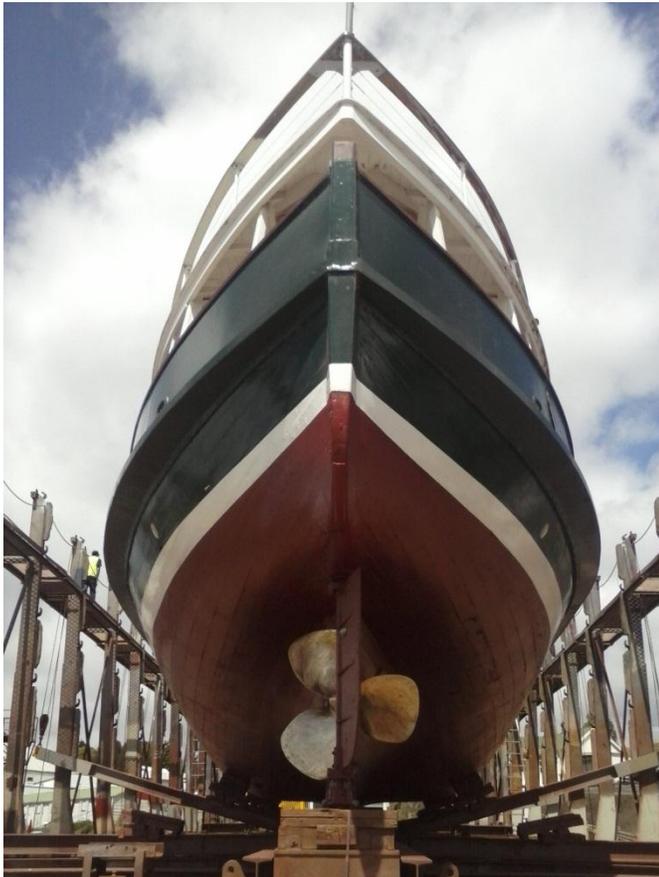
Designing a vessel with the essential ability to be seaworthy in such a variety of difficult conditions while still having the maneuverability to access the numerous jetties of variable qualities encountered around the Peninsular Channel Derwent and Tamar was essential. With access to some rivers and jetty's requiring shallow draft as well. An easy example to illustrate this is the frequent need to reverse off an exposed jetty into any swell, generally ruled out a large, flat transom

stern. Cartela's unusual canoe stern is a perfect example of a design 'fit for purpose'.

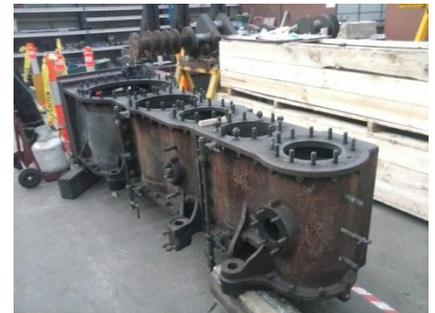
The cylinder head is a collection of three separate castings, each with a working cylinder and valve chest. The

three castings are each very intricately cast and bolted securely together. At present we see no need to separate these casting into individual parts, though now the major task is to make cover plates and individual rubber gaskets to seal every single opening in the castings. This is a huge job. Once the sealed cover plates are in place the cylinder block will be pressure tested. This will involve raising the internal pressure of sections to around 150 psi (10 atmospheres) to ensure that there are no hidden flaws.

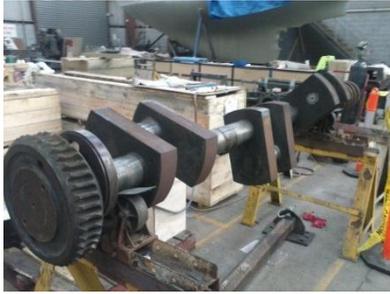
The crankshaft of the engine was originally made from a number of component parts with extremely close tolerances. Each journal (the

cylindrical section that connects via a bearing to either the main bearing caps or a con-rod or valve 'big-end') and the webs (the

rectangular sections between the journals) relies on a 'shrink fit'. That is one part was heated the other part cooled until the metal could be forced together then rely on the metal expansion and contraction to maintain the joint. 'Scotch keys', pins intersect the joint have been inserted over the years to reinforce failing shrink fit joints. Most of the journals are deeply worn and show signs of substantial reworking as would be expected over its 50 years of work. There is also an amount of 'run-out' in the crankshaft. Basically it is slightly

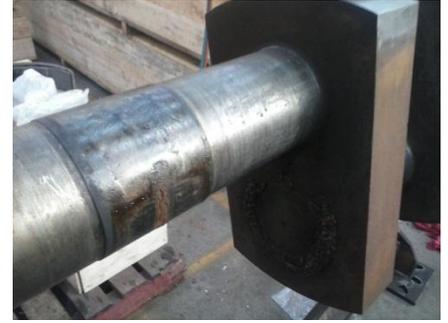
bent. All of this means that a new crankshaft will need to be made. Tony Reeve at Saunders and Ward suggests

re-using the webs and recreating the journals from new stock. This will maintain originality and allow use of the normal bearing methods as just milling a new surface on the existing journals and straightening will result in a weaker structure, and possible trouble in years ahead. We are aiming for an engine that in all respects is like a new one with no reason to expect less than another 50 years of service.
